## Beautiful Basements Case Study Lift Pit Waterproofing - Ashby, Leicestershire

**Client**  
**Waterproofing Designers**

**United Biscuits**  
**Beautiful Basements**

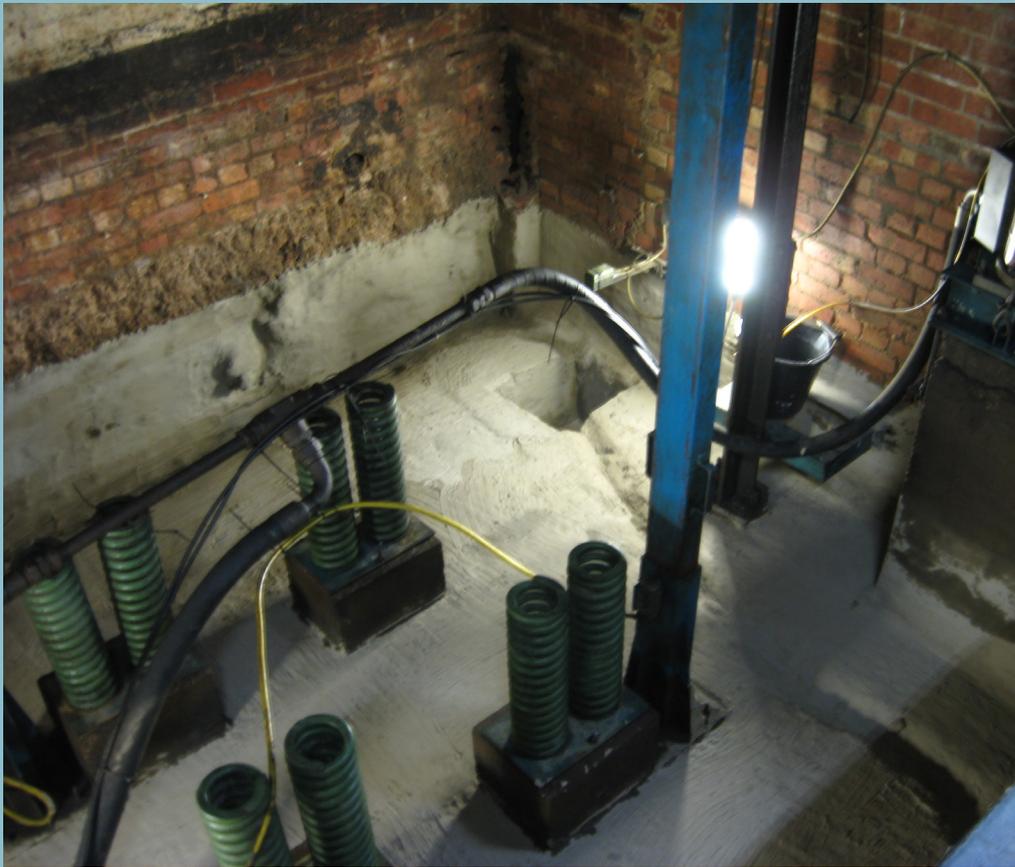
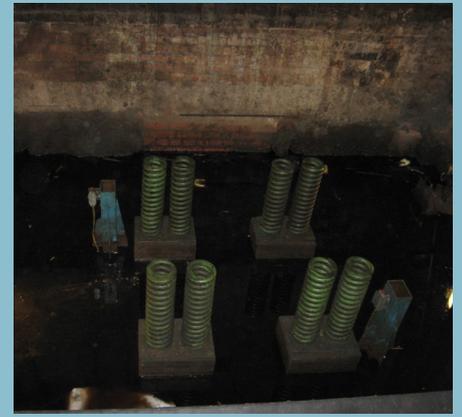
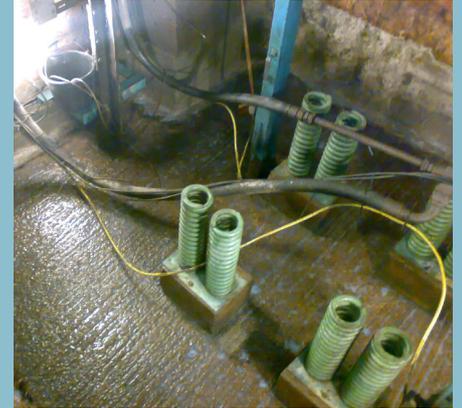
At the large United Biscuit factory where bagged foods such as crisps and biscuits are produced, a lift pit had been subject to a hydraulic oil leak for around 15 years, with water ingress mixing with the oil to make an incredibly thick and dirty black film on all surfaces.

Beautiful Basements were brought on board to solve the water ingress problem. All the surfaces were extensively cleaned and prepared ready for waterproofing. In a series of stages the walls and floor were repaired and primed using Köster Aquatecnic waterproofing slurries. The waterproofing consisted of 3 coats of waterproofing slurry and finished with an oil resistant wearing coat to prevent oil breaking the slurry down.

Type A – Internal Barrier Protection

Two coats of cementitious slurry with SBR additives.
