Beautiful Basements Case Study Cesspit Waterproofing - Shrewsbury, Shrops

Waterproofing Method

Type A – Internal Barrier Protection

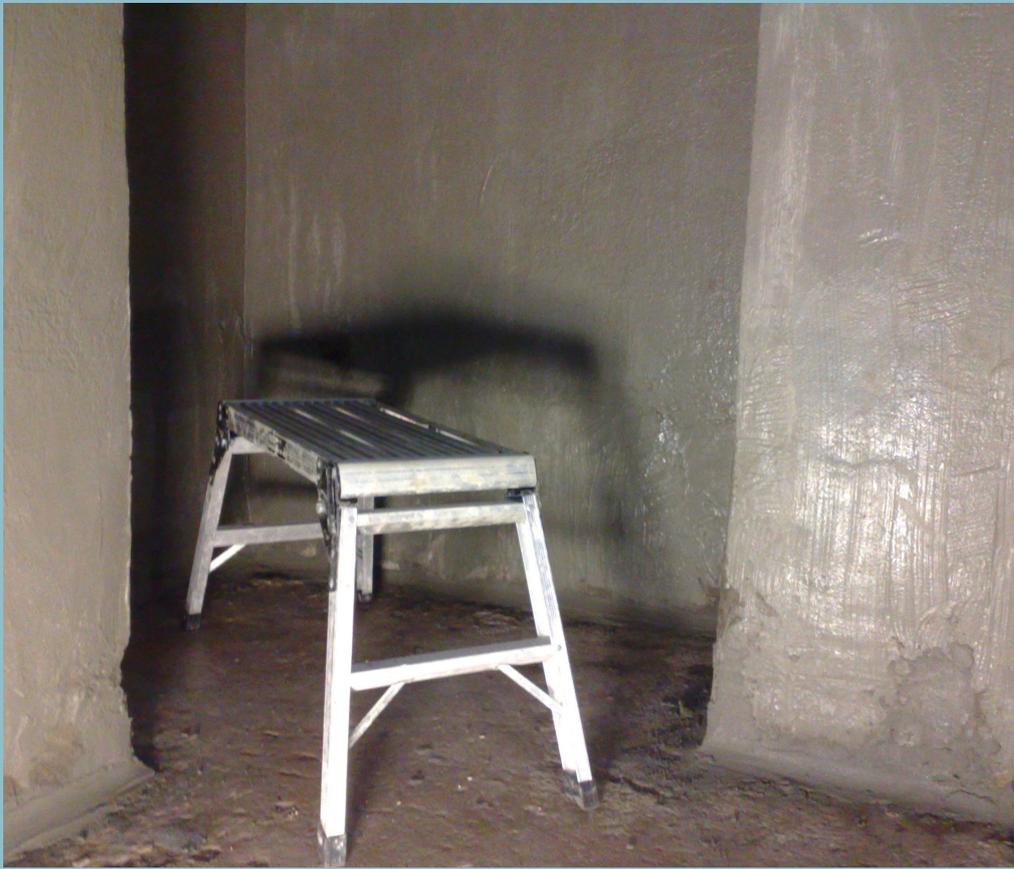
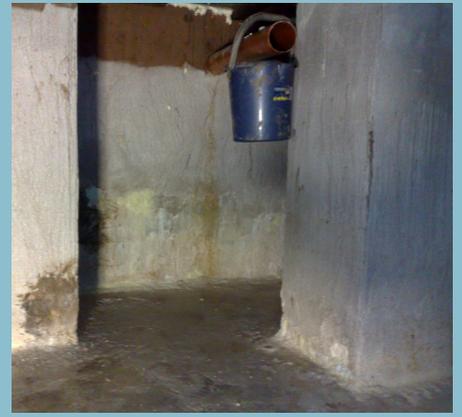
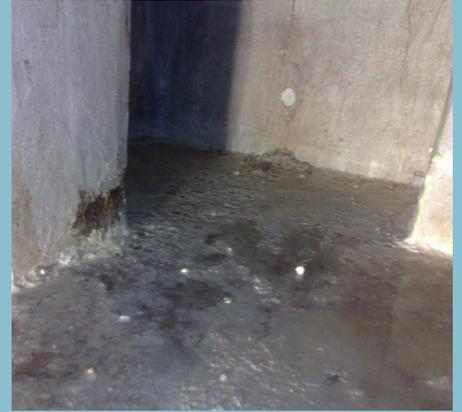
18th Century Church in a rural setting 5 miles outside Shrewsbury, Shropshire had a cesspit build to accommodate inhabitants under new government guidelines. Built from blocks with a concrete base and render finish it had no waterproofing at all.

After the initial build it began to leak and several attempts were made to waterproof the pit, unsuccessfully. Water was coming it at such a rate it would have filled the pit three times as fast as designed, meaning much more frequent, and very costly emptying. Beautiful Basements were called in to try and solve the problem. The substrate was extensively cleaned and taken back to the original render, any defects in render or concrete on the floor were repaired and all surfaces in the pit were primed and waterproofed using a range of Köster Aquatecnic's cementitious range of slurries.

Two coats of cementitious slurry with SBR additives.
